Contract #: 04-0120F4Cty: SF/ALA Rte: 80 PM: 13.2/13.9File #: 13.28**WELDING INSPECTION REPORT****Resident Engineer:** Pursell, Gary**Address:** 333 Burma Road**City:** Oakland, CA 94607**Report No:** WIR-012792**Date Inspected:** 17-Mar-2010**Project Name:** SAS Superstructure**OSM Arrival Time:** 1000**Prime Contractor:** American Bridge/Fluor Enterprises, a JV**OSM Departure Time:** 1830**Contractor:** Oregon Iron Works Clackamas, Or.**Location:** Clackamas, OR**CWI Name:** M. Gregson, J. Salazar**CWI Present:** Yes No**Inspected CWI report:** Yes No N/A**Rod Oven in Use:** Yes No N/A**Electrode to specification:** Yes No N/A**Weld Procedures Followed:** Yes No N/A**Qualified Welders:** Yes No N/A**Verified Joint Fit-up:** Yes No N/A**Approved Drawings:** Yes No N/A**Approved WPS:** Yes No N/A**Delayed / Cancelled:** Yes No N/A**Bridge No:** 34-0006**Component:** Hinge K Pipe Beams**Summary of Items Observed:**

Hinge-K Pipe Beam Assembly 102A-2:

Hinge-K Pipe Beam Assembly 101A-1:

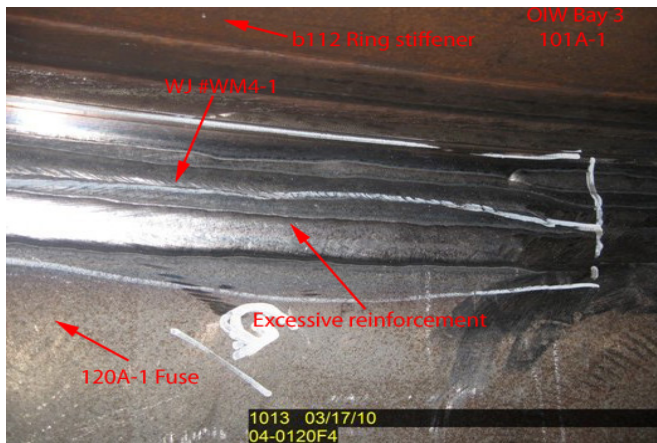
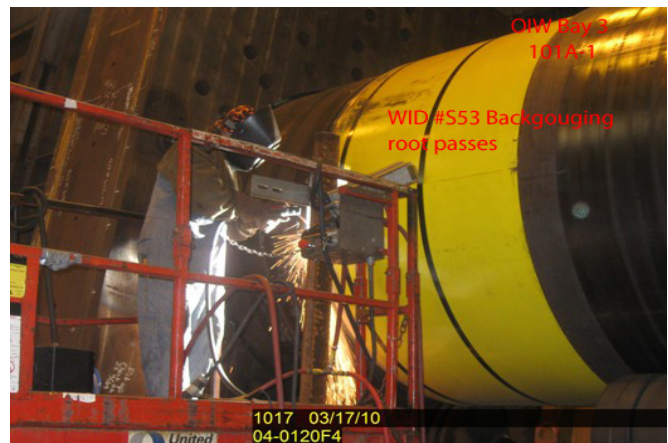
The QA Inspector witnessed WID #S53 (Jerry Shepherd), performing the backgouge on the previously completed

root pass, designated as weld joint (WJ) # WM4-1. The QA Inspector noted that this WJ was the 120A-1 Fuse to 102A-1 Forging and was designated as an AWS D1.5 B-U7-S Complete Joint Penetration (CJP), double U Groove, with a 20 degree included angle bevel prep. The QA Inspector noted that WID #S53 was performing the backgouge, utilizing the Carbon Arc process and that pre-heat was intermittently applied, with a stationary torch. The QA Inspector noted that QC Inspector Jose´ Salazar was present and QC Inspector Salazar explained that the pre-heat was verified, prior to starting the Carbon Arcing. The QA Inspector noted that the minimum temperature required is 150 degrees Fahrenheit, per AWS D1.5. QC Inspector Salazar explained that the Carbon Arcing will continue and then mechanical grinding will then be performed, to grind the root pass to sound, clean metal. QC Inspector Salazar explained that the backgouging will continue to depth of approximately 65 mm and he will then verify the depth and perform 100% Visual and Magnetic Particle Testing (VT/MT) on the backgouge. QC Inspector Salazar explained that he had previously performed Visual Testing (VT) on the interior completed cover passes on this Weld Joint (WJ) # WM4-1. QC Inspector Salazar explained that he had measured areas of excessive reinforcement, utilizing a bridge cam gauge, which exceeded 1/8" (3 mm). QC Inspector Salazar explained that he had marked up the areas for Visual repair and notified Production Lead Troy Smith. See attached pictures below.
